SUBJECT: Presentation of HSMM Building Assessment for the Tuxedo Elementary School

Building Assessment Tuxedo Elementary School

for
Henderson County

January 2006

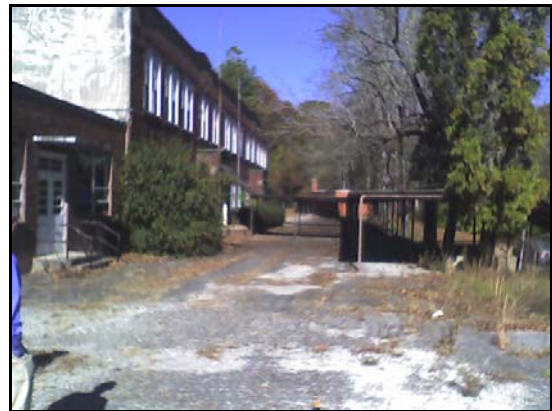
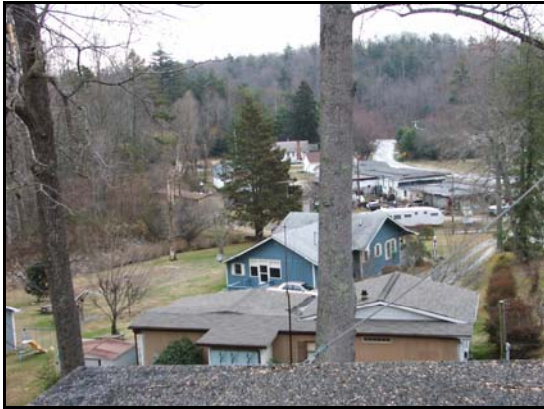
The 6.93 acre property has three existing entrances off Old U.S. Highway 25 and has about 600' of road frontage. Although the road is below the site there appears to be no limit to placing future access points in different locations from the existing ones.

The site terraces up from the east with a parking area below the level of the existing buildings and a playfield on the upper terrace at the west end of the site. South of the buildings is a relatively large level area originally used as an activity area. There is a severe slope to the area between the upper playfields and the terrace where the buildings are located. There is a less steep slope between the parking area and the building terrace but there is not an accessible pathway from the parking area to the building as it is currently configured. The westernmost drive does provide access to the building at grade.

The site presents a good view of the main building from the highway, and its orientation faces the easternmost entrance to the site. The kindergarten building is mostly hidden from view of the road. Views from the second floor of the main

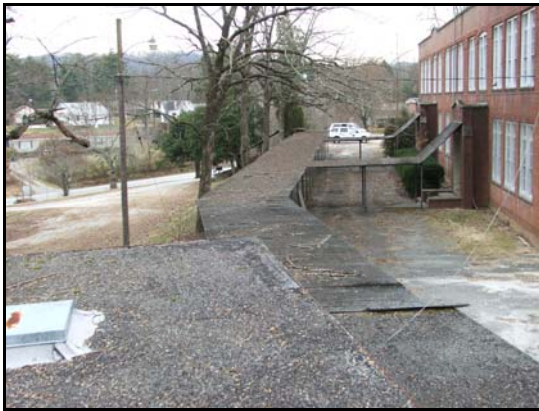
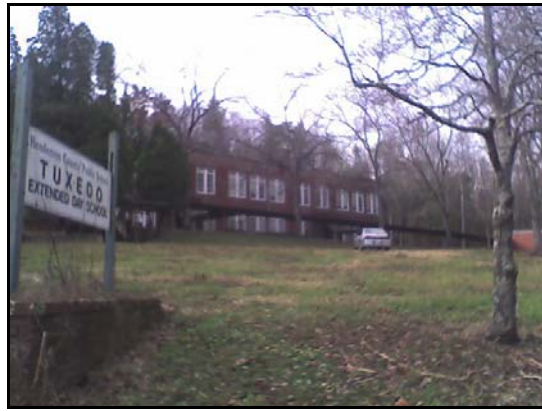
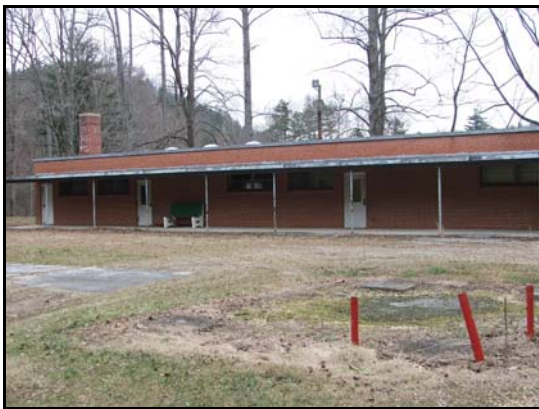
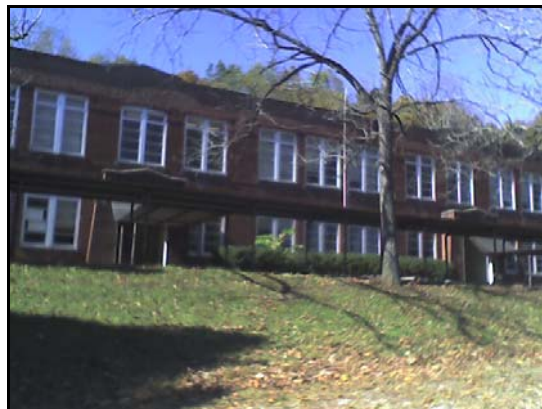
The asphalt paving is in deteriorated condition and will need to be replaced for any future use. There are no sidewalks connecting the site to the surrounding neighborhood.

Public water and sewer are not available for use at this site at this time. The on-site water well and sanitary septic field

have proven adequate for both of the school buildings throughout their history and would probably be adequate for any type of future facility requiring similar plumbing fixture unit counts. If the next building use has a much higher plumbing fixture count, the water well and septic field should be replaced with public water and sewer.

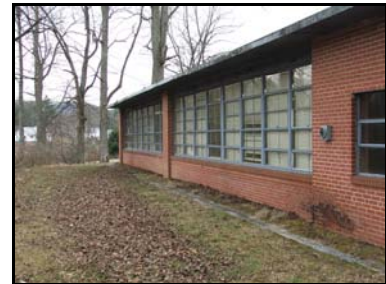
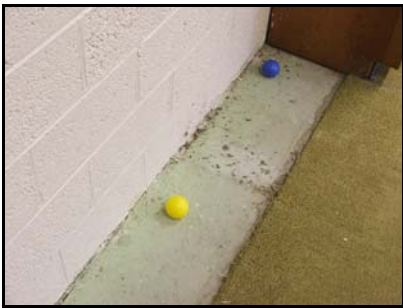
The 2600 SF Kindergarten Building was constructed in 1956 and consists of two classrooms and a boiler room. Its design is typical of school buildings designed in the 50's, with windows extending the width of the exterior wall and stretching from cabinet height to the underside of the roof structure. Skylights

(blocked out in one room) provided light to the interior of the rooms. Floors are mostly carpet or sheet vinyl over concrete, with tile in the single toilets off the classrooms.

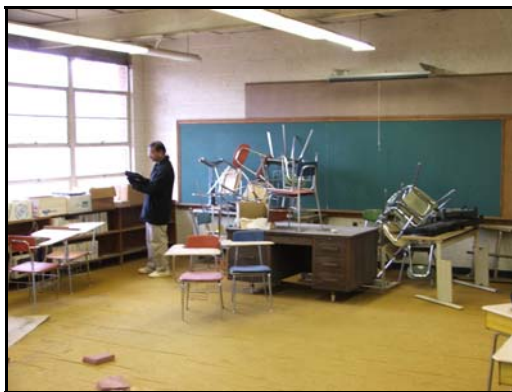
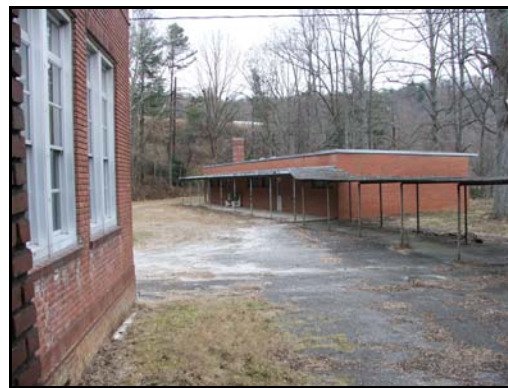
Exterior walls are 12-inch cavity brick walls. Partition walls are brick walls. There was some cracking in the interior masonry wall where it intersects with the exterior wall. It is assumed that most of this cracking is caused by either thermal movement of the building or soil settlement under the wall. Additional detailed investigation is required to find the definite cause of the cracking in the wall. All the remaining walls appear to be in good condition.

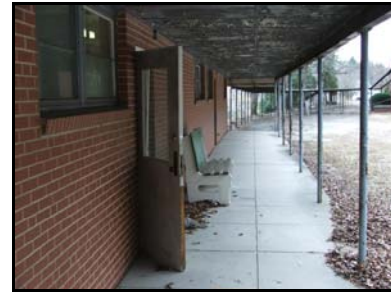
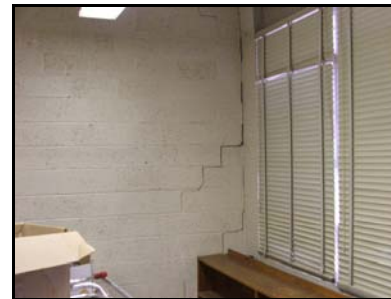
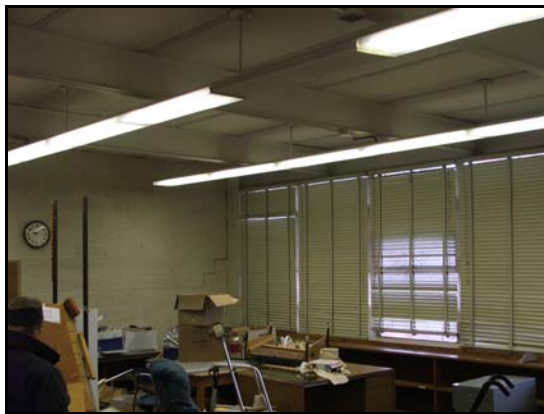
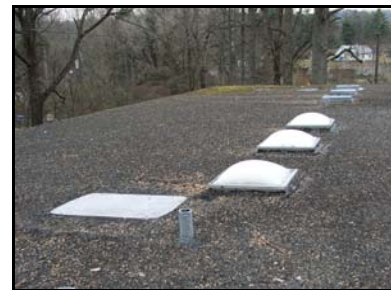
The roof consists of a concrete slab supported by steel members. The slab and the interior steel members appear to be in good condition. Most of the exterior exposed steel members have visible rust and require immediate attention to provide rust inhibitive treatment. The canopy connecting the Kindergarten Building to the Main Building is in poor condition and would be unlikely to remain as part of a future use for the buildings.

The overall building structure was found to be in good condition, with no visual evidence of any significant structural problems.

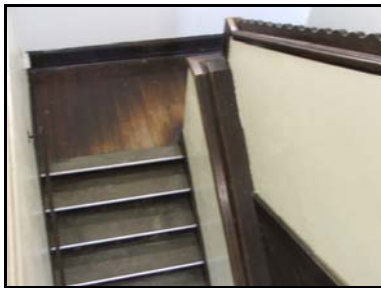
Exterior walls are 12-inch cavity brick walls. Portions of the rear walls are plastered masonry. Partition walls are either brick or wood. All the walls appear to be in good condition.

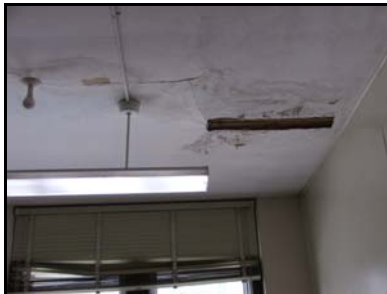
The overall building structure was found to be in good condition, with no visual evidence of any significant structural problems. Some cracks and staining on the ceiling caused by roof leaks were observed in some areas of the building. Additional detailed investigation is required to find the cause of the cracks and water leakage.

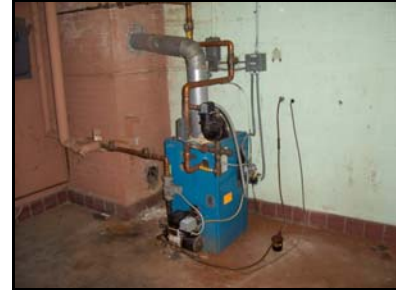
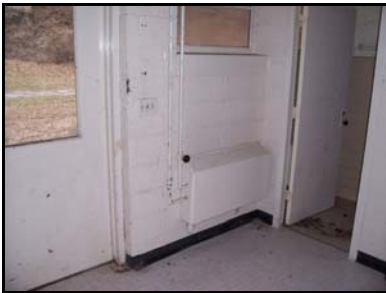
The existing heating system for the Kindergarten building consists of an oil-fired heating hot water furnace and “heating only” wall hung fin tube radiators. The furnace and hot water circulating pump have 153,000 BTUH output, appear to be in good running condition, and could probably be re-used in the building’s next use. The wall hung fin tube radiators hung along the walls appeared in good condition though the radiator exterior covers were damaged in various locations. It is recommended to replace all existing radiator covers with new covers with the next facility use.

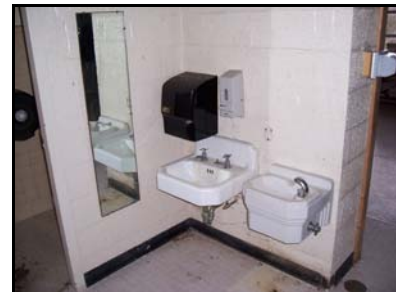
The plumbing system has a 40 gallon electric hot water heater which is appears in good condition and could be re-used if the building’s new use will allow it. All existing plumbing fixtures are children’s type installed at children’s plumbing heights. The plumbing fixtures are old, damaged in some cases, and all fixtures should be replaced with the building’s next use. The teacher’s bathroom plumbing fixtures are old and all should be replaced in the future.

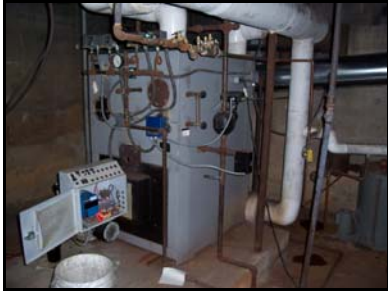
The existing heating for the main School building consists of a basement oil-fired steam boiler and steam radiators installed throughout the building in various locations. The boiler has 892,000 BTUH steam output, appears in good working condition, and could probably be re-used in the building's new life. The boiler level control appears to have had a manual reset button installed and should be adequate. All building steam radiators, controller, and steam traps could be re-used if the occupants would accept steam heat. The existing steam condensate pump appears in good working order and could be re-used. There are also a few electric baseboard wall heaters which have been installed in the building over the years due to partition additions which could be re-used if needed.

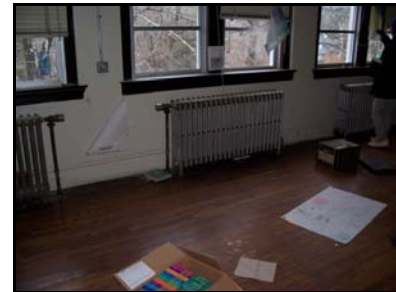
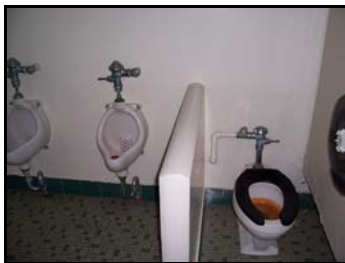
There is no air conditioning in the main building and the only ventilation is opening windows and allowing air to travel up numerous building ventilation grilles and out of the building via a "chimney effect". Due to the relatively cool climate during the summer in this area and the buildings high ceilings, this ventilation system may be adequate in future building uses. If air conditioning is desired, a new air conditioning system will be needed.

There are no toilet exhaust fans installed in the toilet areas. All toilet areas observed have operable windows meaning toilet fans will not have to be installed but it is recommended to do so due to winter conditions.

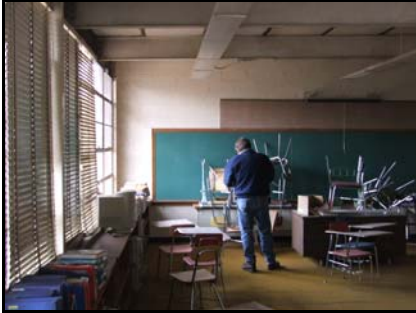
The Kindergarten Building is fed from an overhead drop located at the north east corner. This service feed comes from an off campus, pole mounted transformer of an unknown size. The electrical service is 120/240Vac, single phase, and feeds directly into a 200A service disconnect located in a storage area on the north east building corner. This electrical space contains a 200A, 24 circuit panel that is used for building distribution.

Each of the two existing classrooms has minimal use of electrical outlets. The outlets that are in the classrooms are wall mounted in exposed boxes and placed in positions that make practical use difficult. All conduits to the electrical devices were surface mounted. There were no outside outlet devices observed on this building.

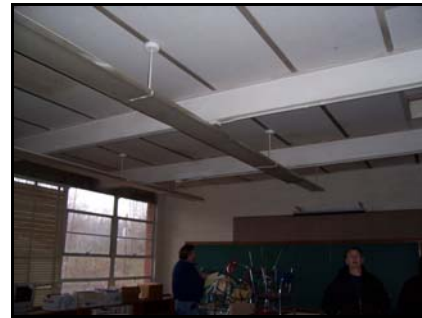
The existing lighting in the classrooms is three rows of suspended fluorescent lighting in various states of repair. There was no observed outside lighting by the classroom entrances or the covered walkway.

Each of the classrooms has ceiling mounted smoke detectors along with a single station horn / strobe and single pull station located by the exit door.

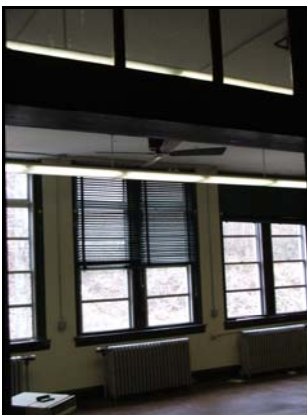
The main school building is fed from an overhead drop located at the building's north end. This service comes from an off campus, pole-mounted transformer of an unknown size. The electrical service is 120/240Vac, single phase, and feeds into a sealed tray located in the basement boiler room. At this location, the service is split into 2 – 200A runs feeding the north and south building ends. There are smaller, 125A lighting panels located in the 1st floor copy room and a 2nd floor hallway that are used for further distribution.

All of the classrooms, office areas, and auxiliary rooms have a minimal number of electrical outlets. All of the outlets are surface boxes, wall mounted, and in locations that make their use impractical. All conduits to the outlet boxes are surface mounted. There were no outlets observed in the hallways or stairwell areas.

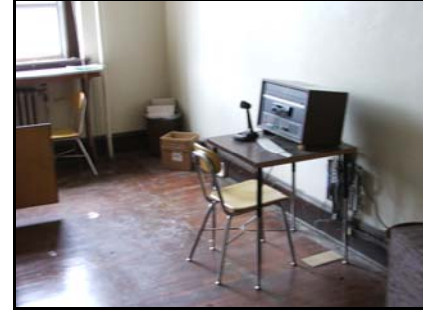
The existing lighting in all areas consists of a combination of surface mounted and suspended fluorescent fixtures. The ceiling height in the majority of the areas is approximately 12 feet. There are wall mounted lighting fixtures with shatter-proof lenses on the stairwell landing areas. There is minimal outside lighting at the building entrances and none observed for the covered walkway.

All areas have ceiling-mounted smoke detectors and the hallway and classroom areas have single station horn/strobes with single pull stations by each exit door. The restrooms however, appeared to have no strobes / horns. Located in the main office is a multi-point fire panel for monitoring the individual detection zones.

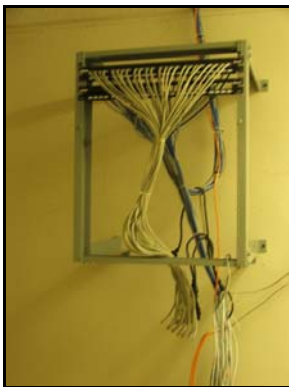
There has been an attempt to run LAN cable and data points to each classroom. A dual point LAN connection point was observed in each classroom located in various locations. There is what appears to be a classroom used for teaching computer classes on the main floor next to the main office. Several "loose" LAN cables have been pulled into the room and coiled on the floor. Located in the main office area is a small room that has been set up as a telecommunications room with "cabling racks" installed.
