HENDERSON COUNTY DETENTION CENTER
HENDERSONVILLE, NC

FACILITY CONDITION ASSESSMENT REPORT

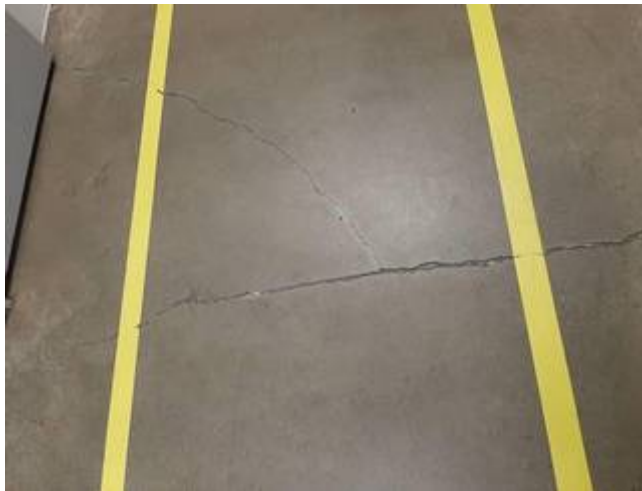
Figure 1 – Example of cracking observed in concrete floor slab.

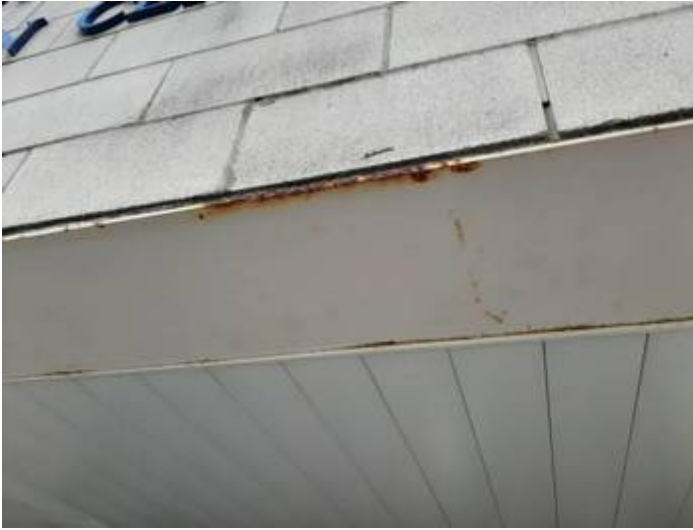
Figure 2 – Example of rust at lintel

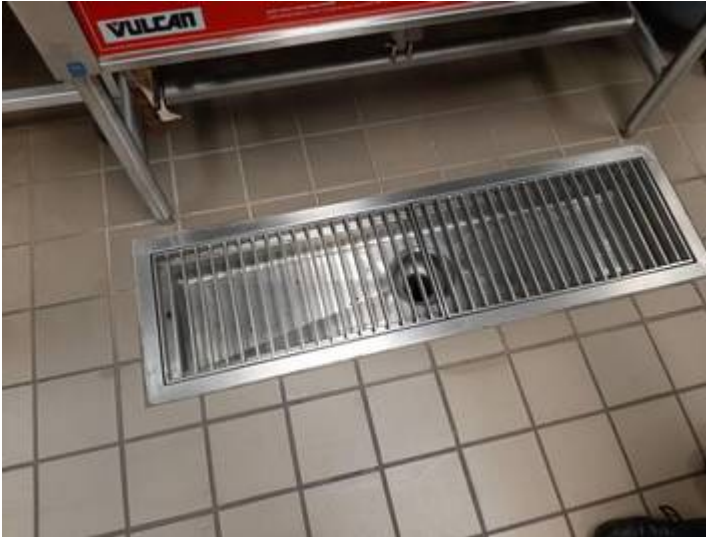
Figure 1– Kitchen floor

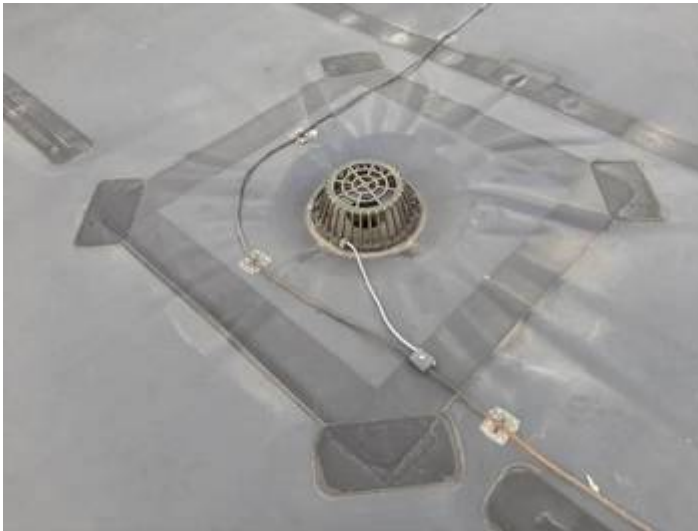
Figure 2 – Roof at roof drain

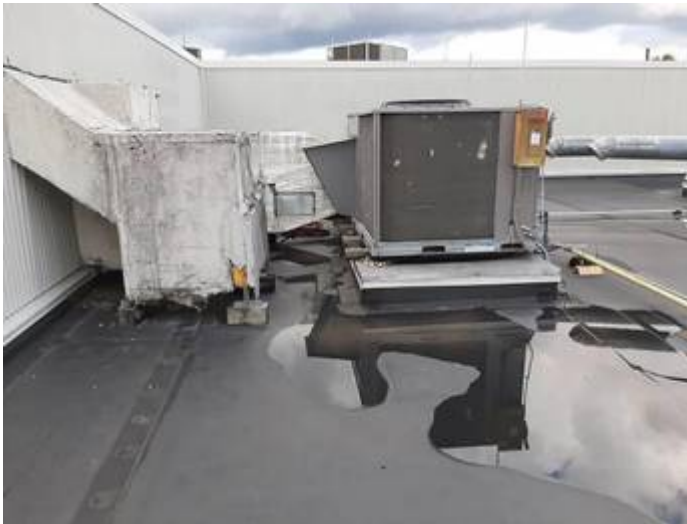
Figure 3 – Roof at support area-Equipment drainage

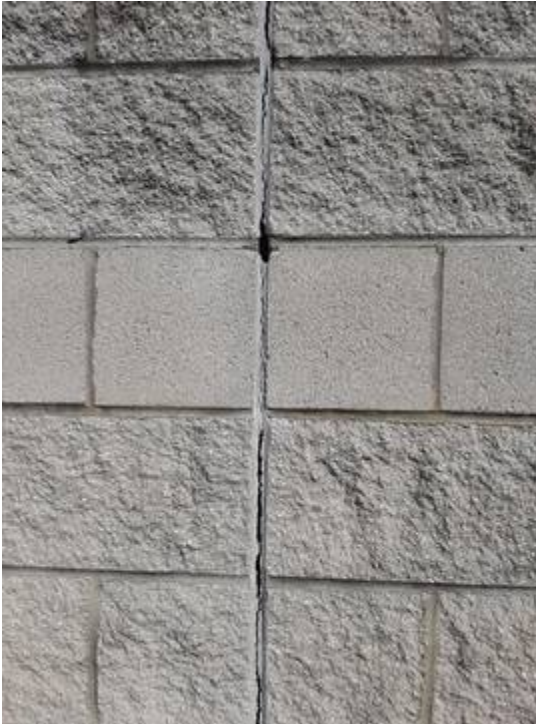
Figure 4– Caulking failure at masonry control joint

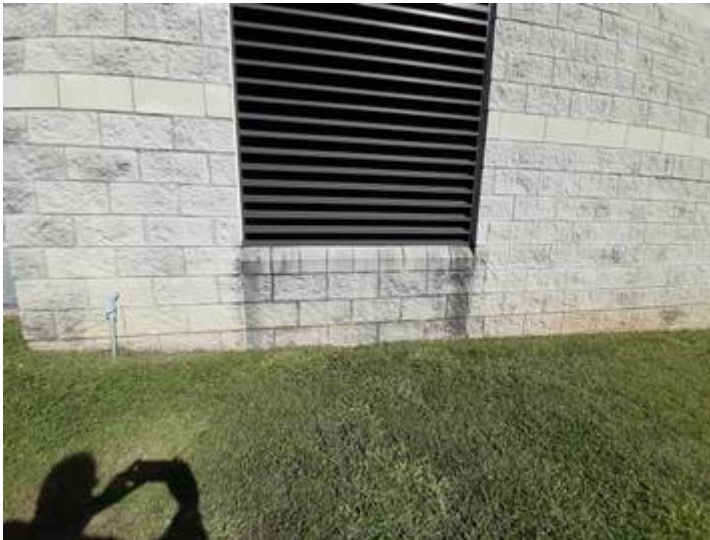
Figure 5– Mold and mildew on exterior walls (louver at vehicular sallyport)

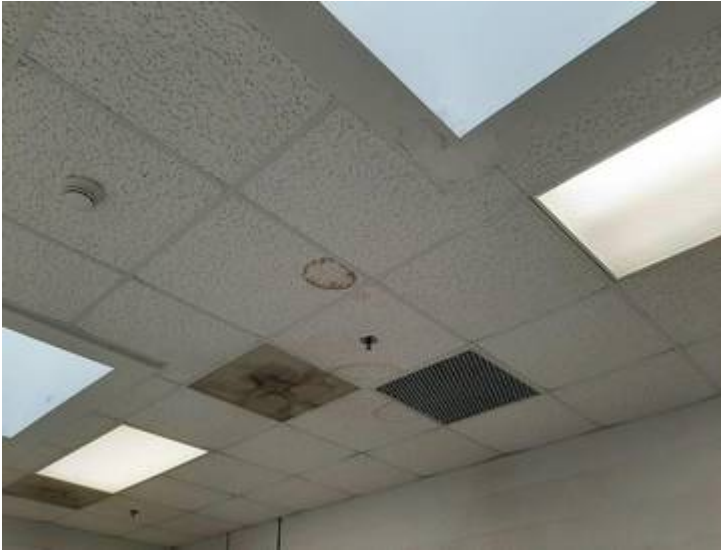
Figure 6– Water damage at ceiling tile; work release.

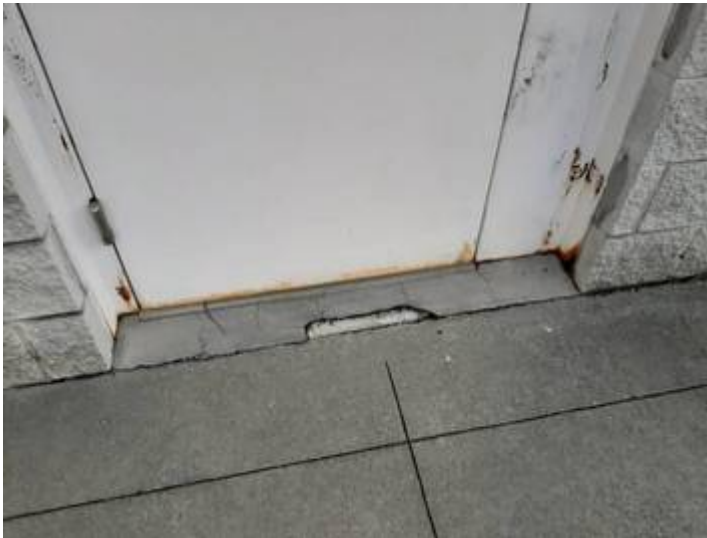
Figure 7– Rust at exterior doors and frames.

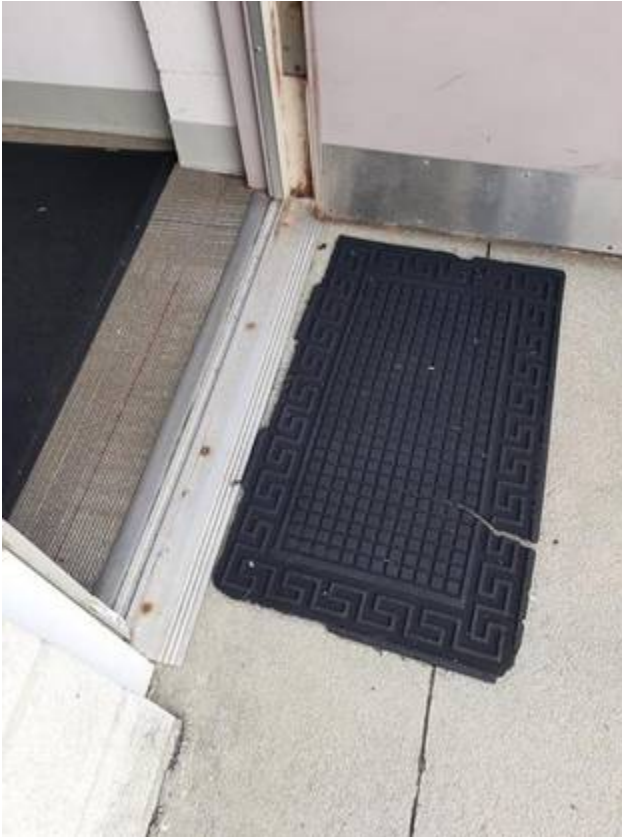
Figure 8– Door at Magistrate area.

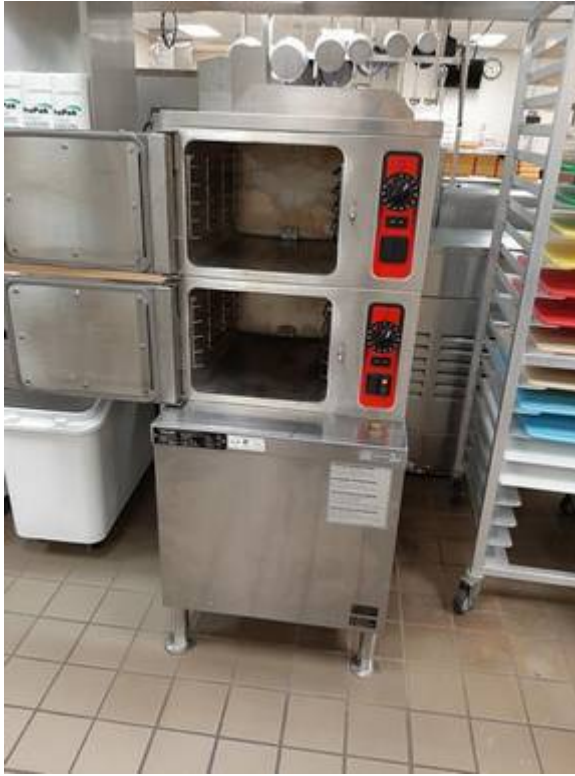
Figure 9 – Kitchen equipment

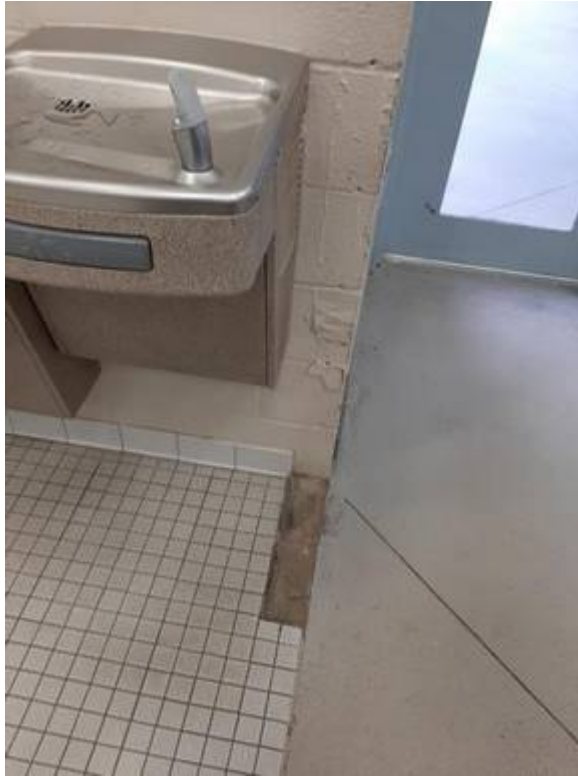
Figure 10 – Broken ceramic floor tile.

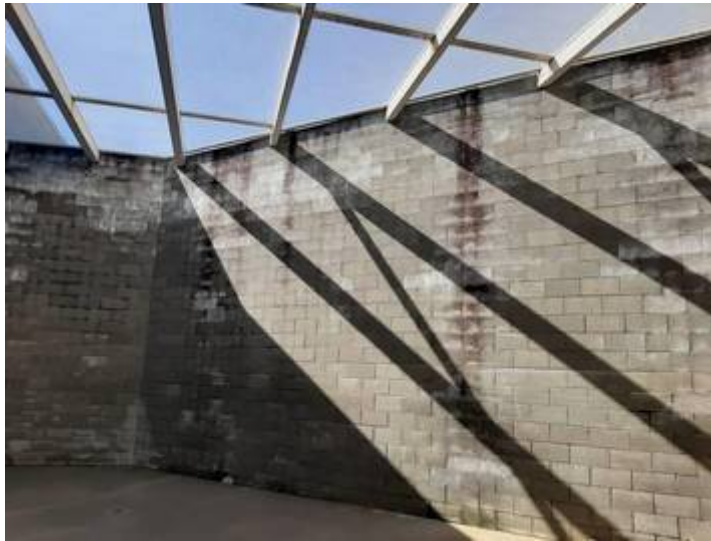
Figure 11 – Mold and efflorescence at minimum housing recreation yard

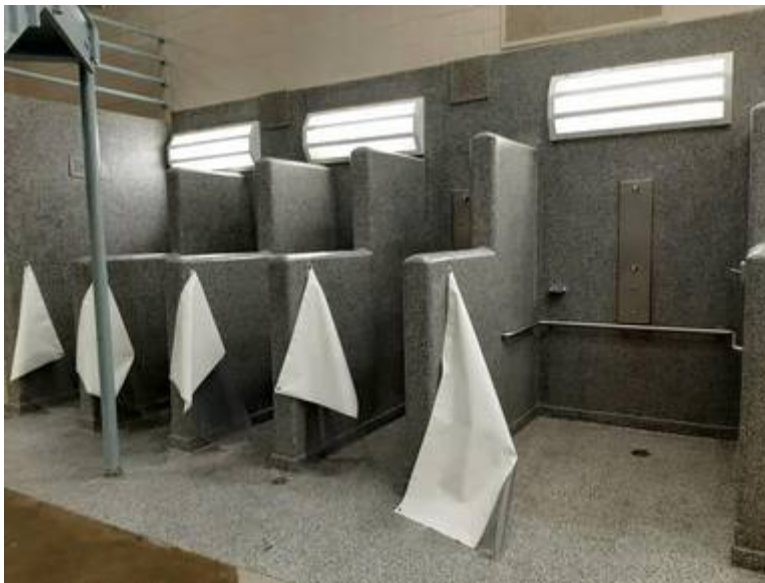
Figure 12 – Coating at inmate showers.

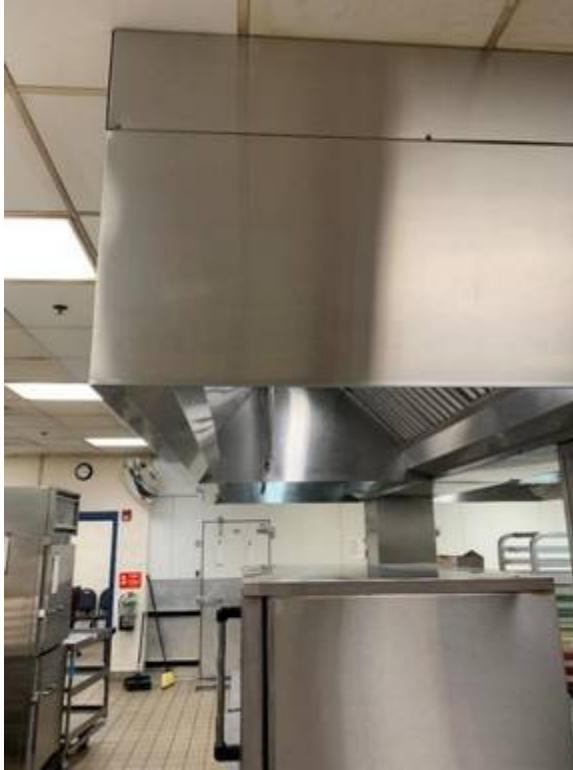
Figure 1 – Kitchen Hood

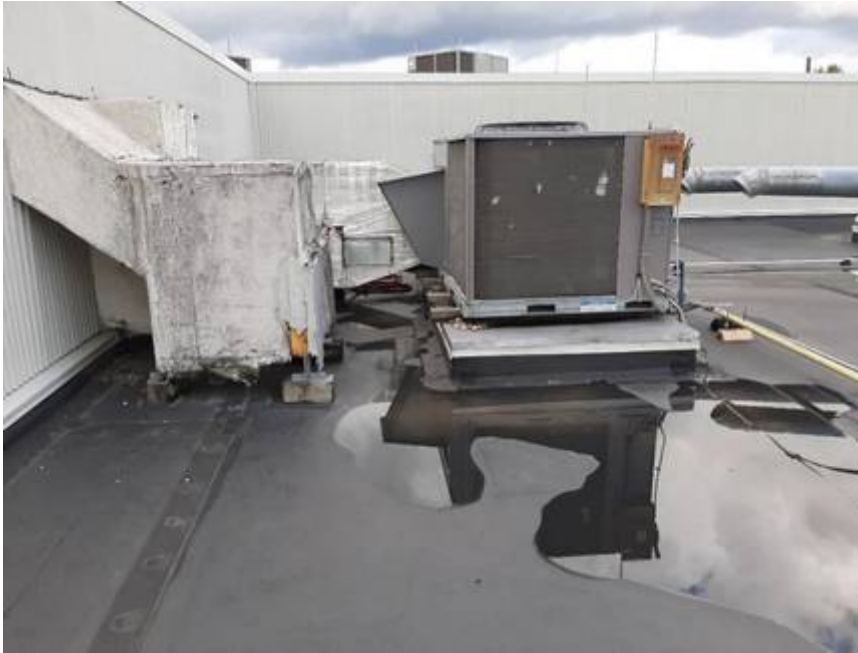
Figure 2 - RTU 5 – Insulation and Exposed ductwork

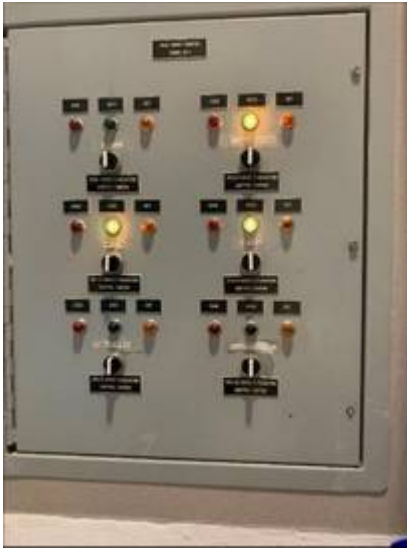
Figure 3 – Smoke Control Panel

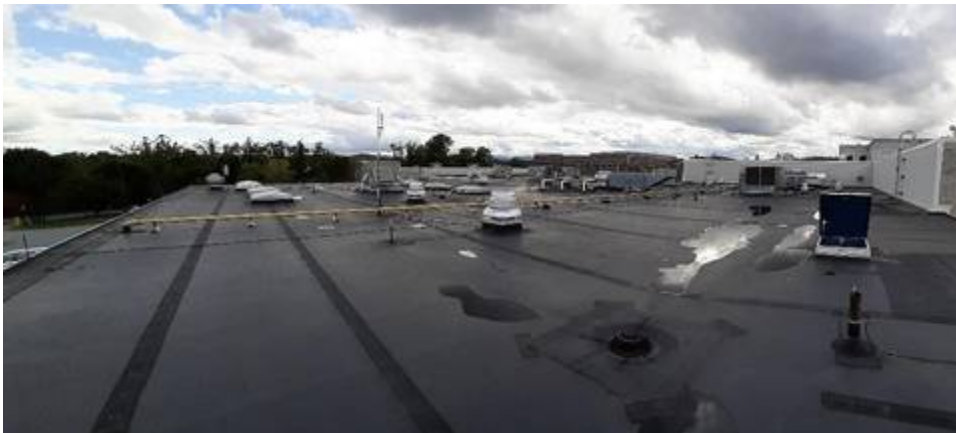
Figure 4 – Mechanical Roof Top Units

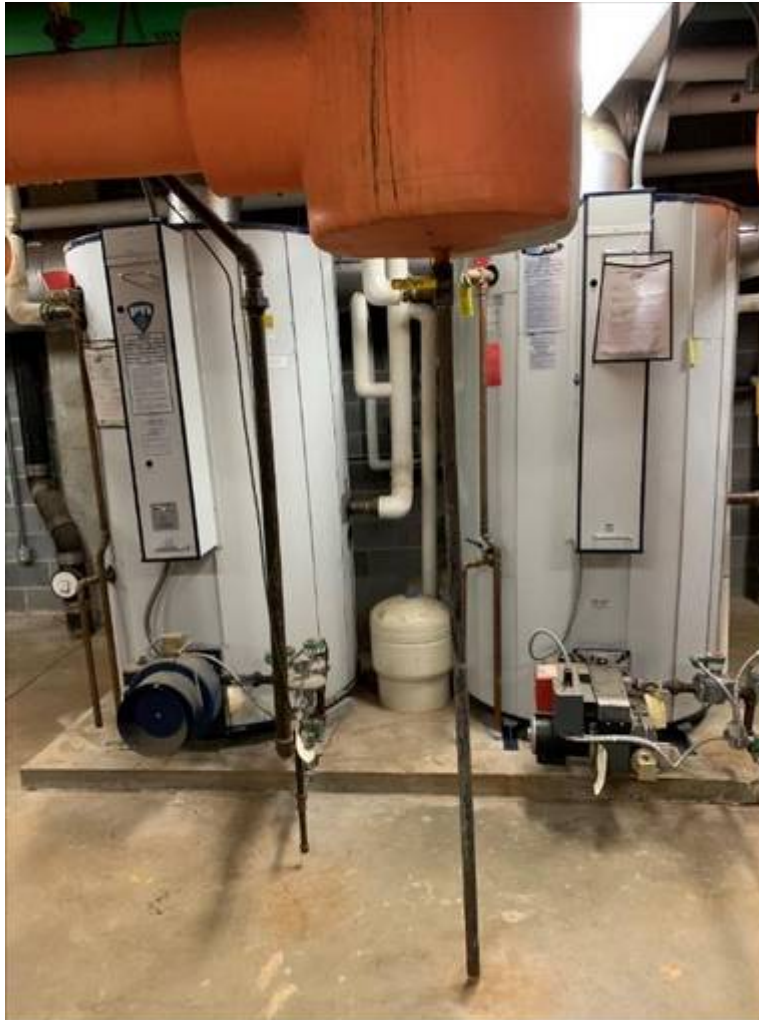
Figure 5 – PVI Hot Water Boilers in Courthouse serving the Detention Center

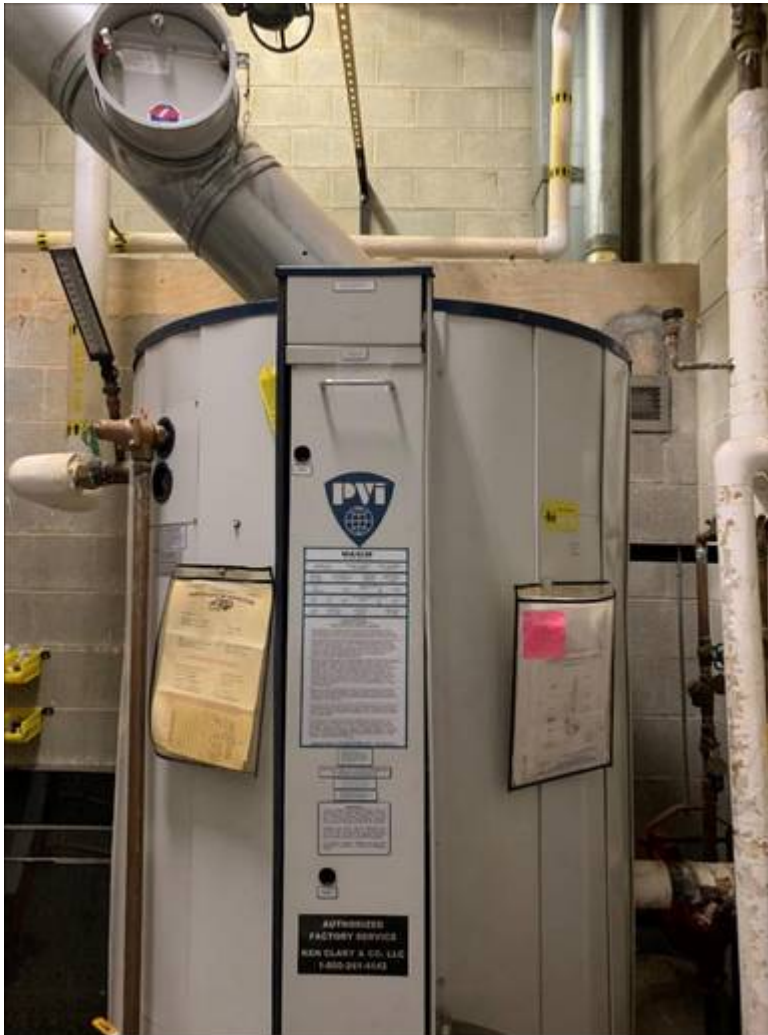
Figure 6 – PVI Hot Water boiler serving Kitchen and Laundry in the Detention Center

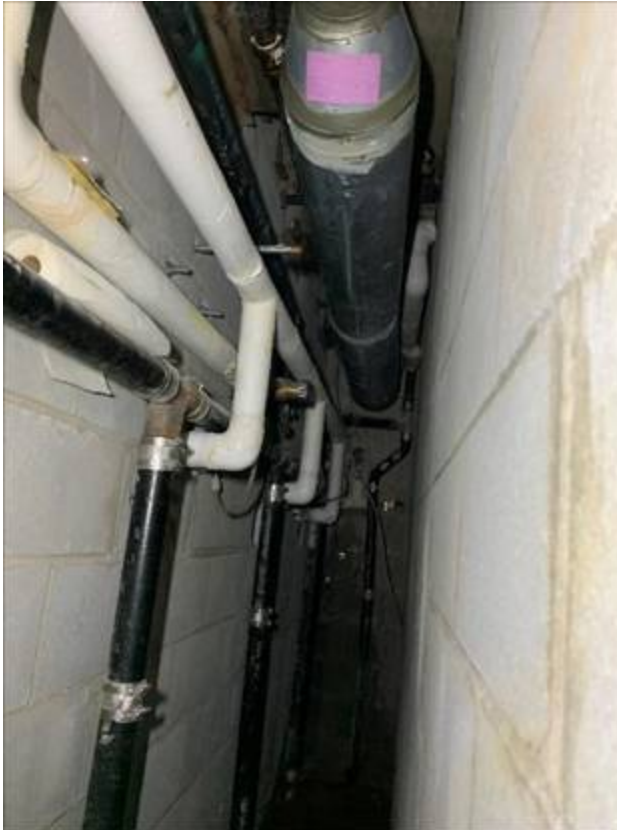
Figure 7 – Housing Unit Plumbing Chase (typical)

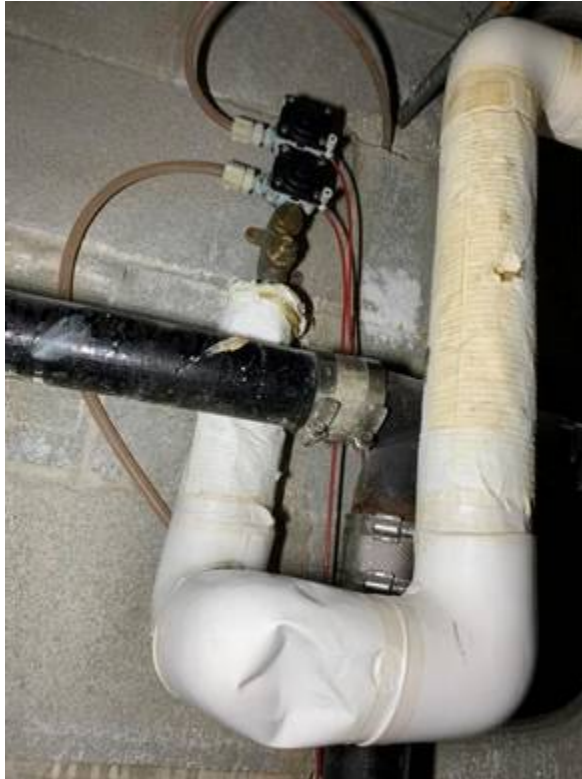
Figure 8 – Pneumatic Water Control Valves, Plumbing Chase

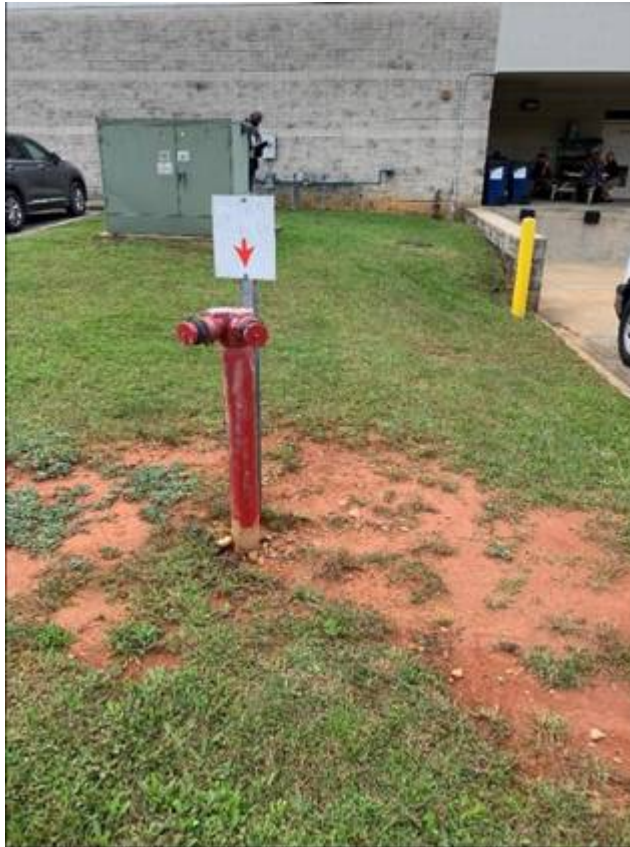
Figure 11 – Fire Department connection

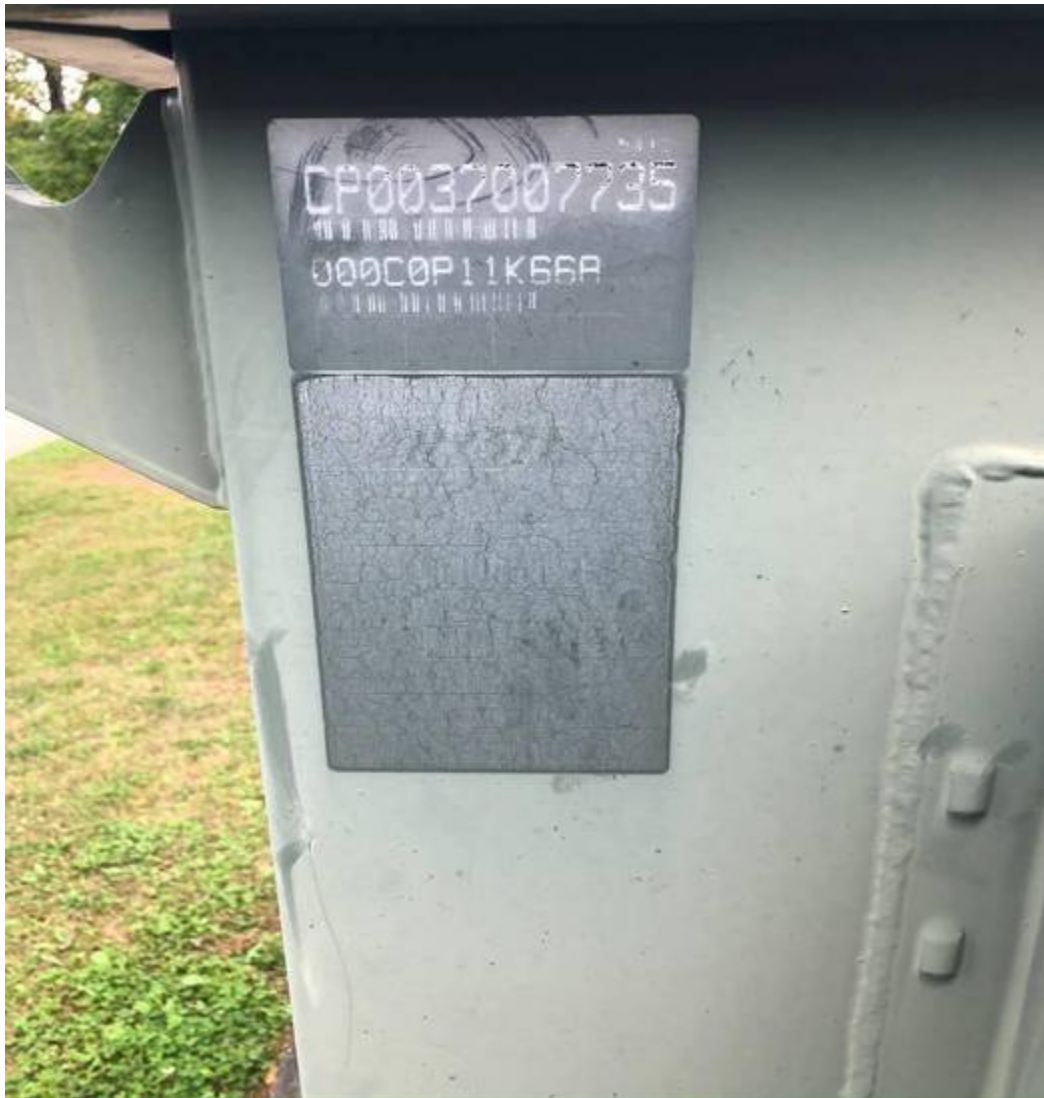
Figure 1 — 500kVA Utility Transformer that supplies power to the facility

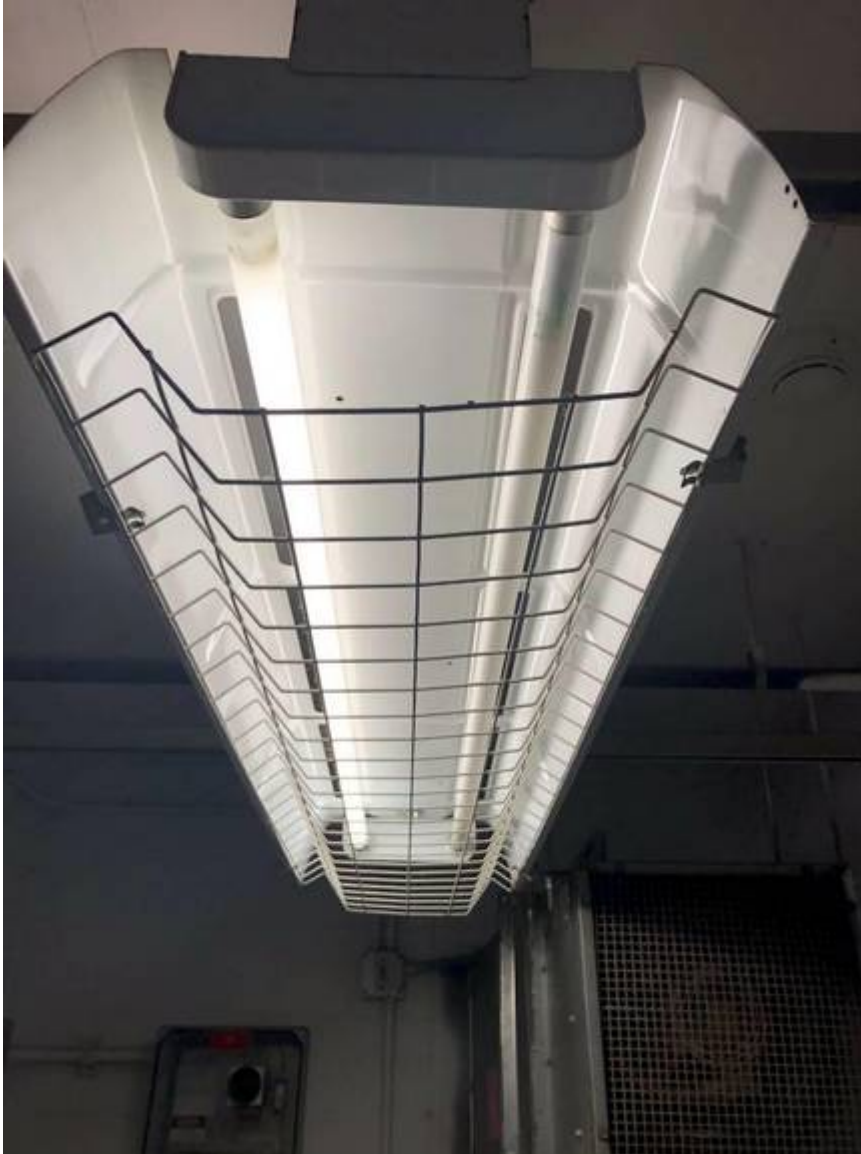
Figure 9 – Lamp replacement needed in several fixtures

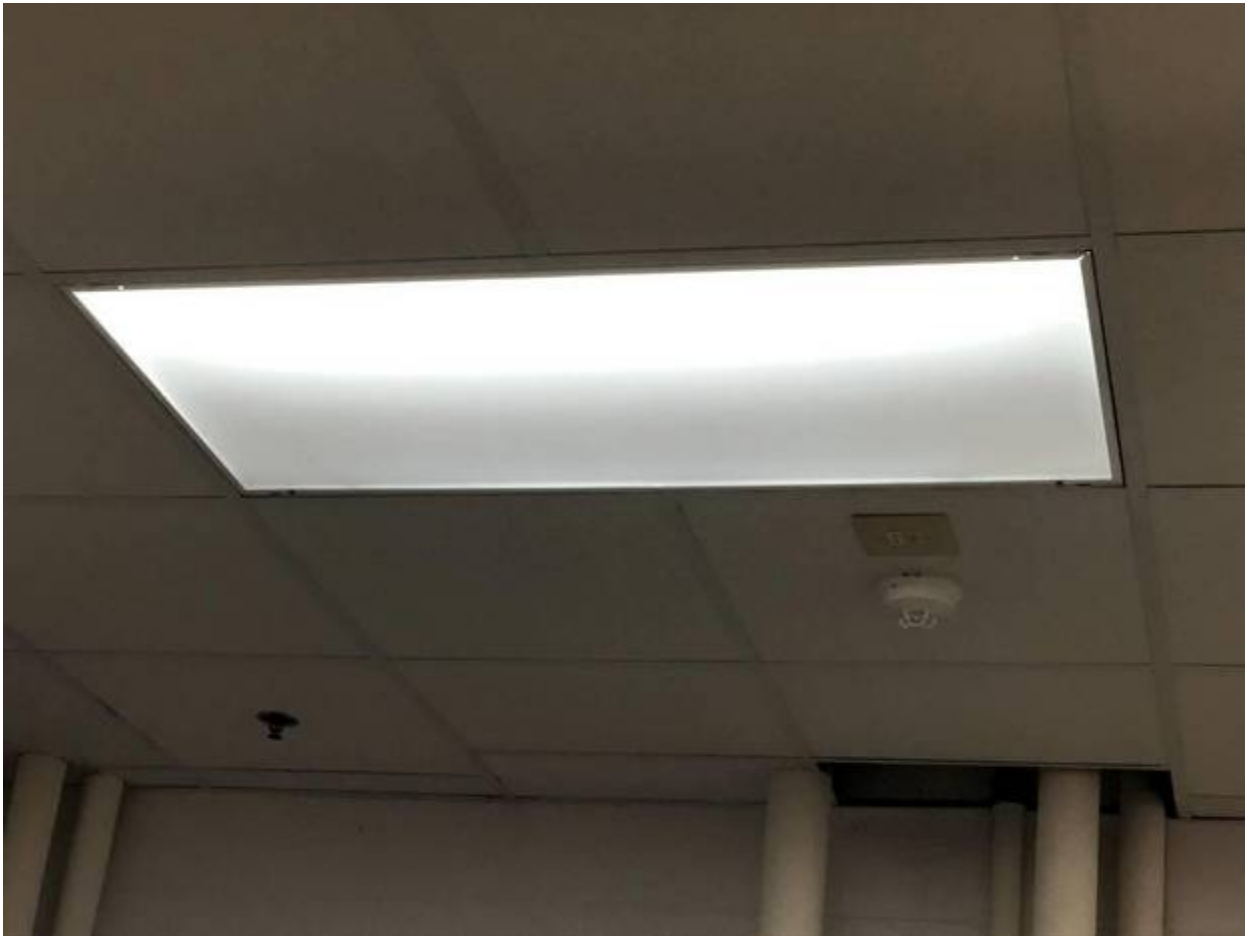
Figure 10 — Lamp replacement needed in several fixtures

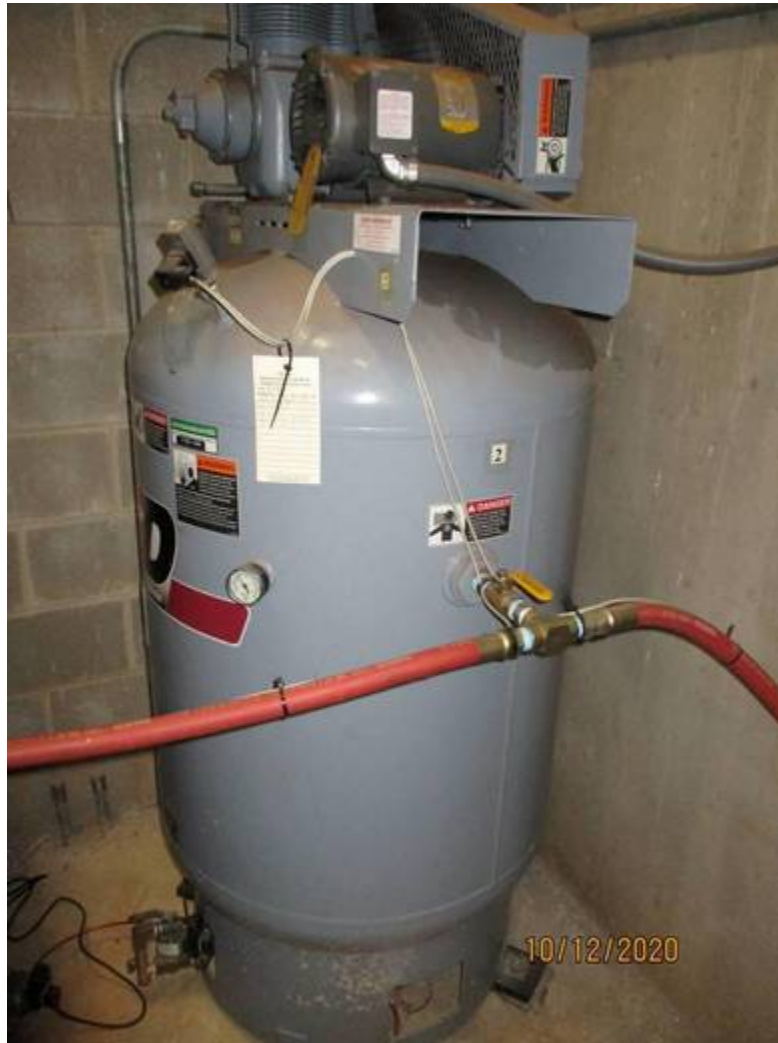
Figure 4 — Gardner Denver Locking Pneumatic Air System Compressor

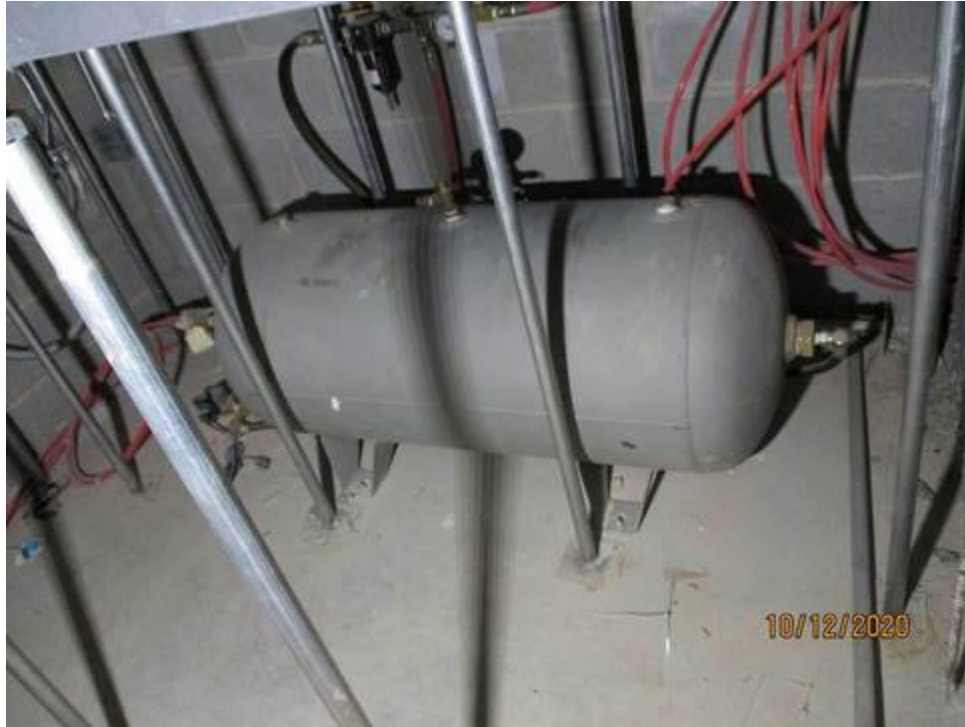
Figure 7— Locking Pneumatic Air System Emergency Reserve tank

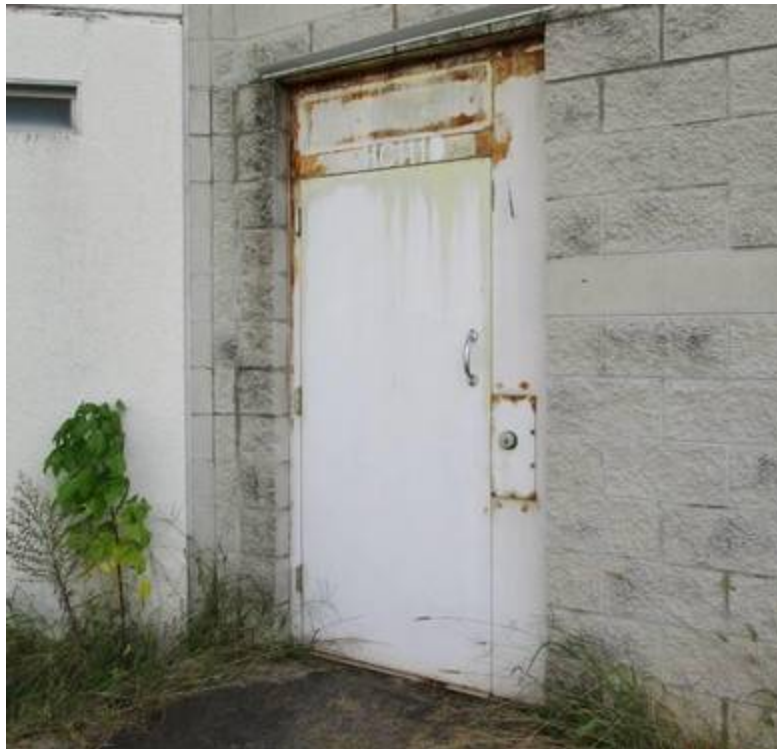
Figure 8 — Surface rusting on an exterior security door and frame.

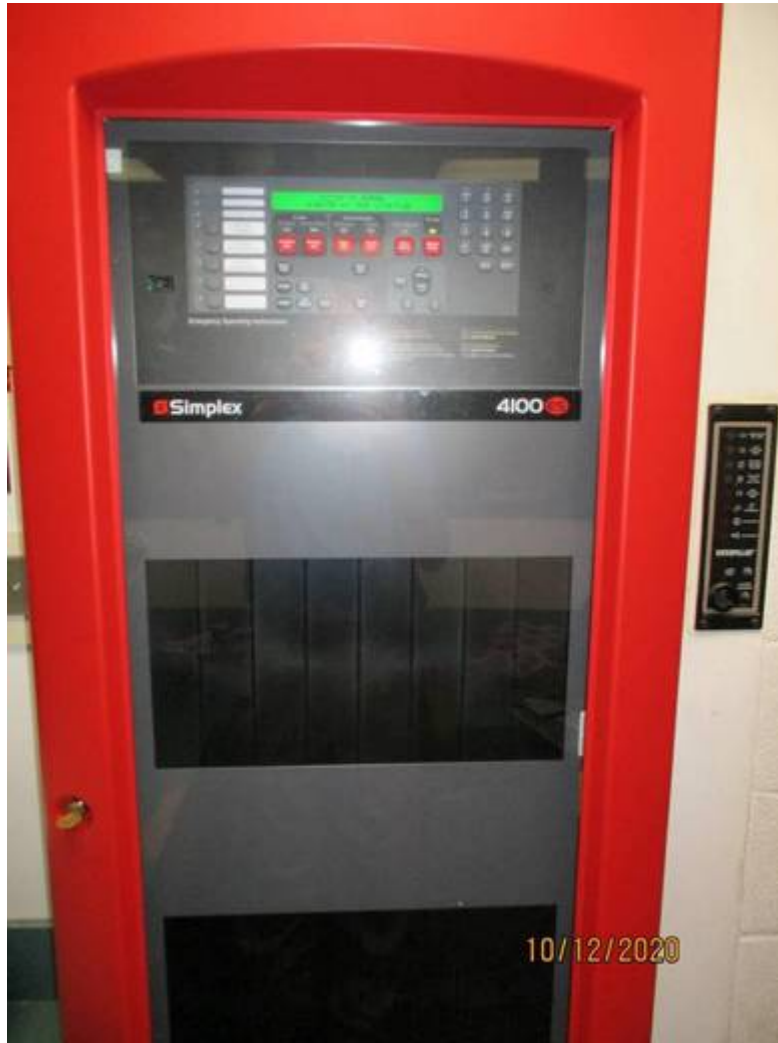
Figure 9 — Simplex 4100 Fire Alarm Panel in Central Control Room

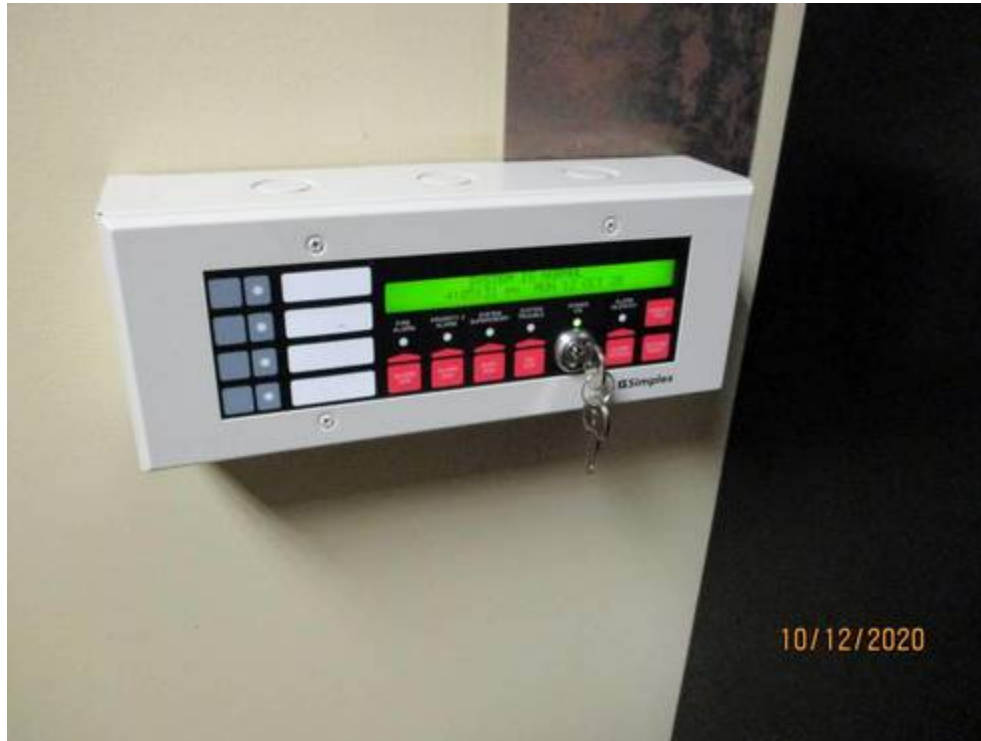
Figure 10 – Fire Alarm System Remote Annunciator Panel (typical)

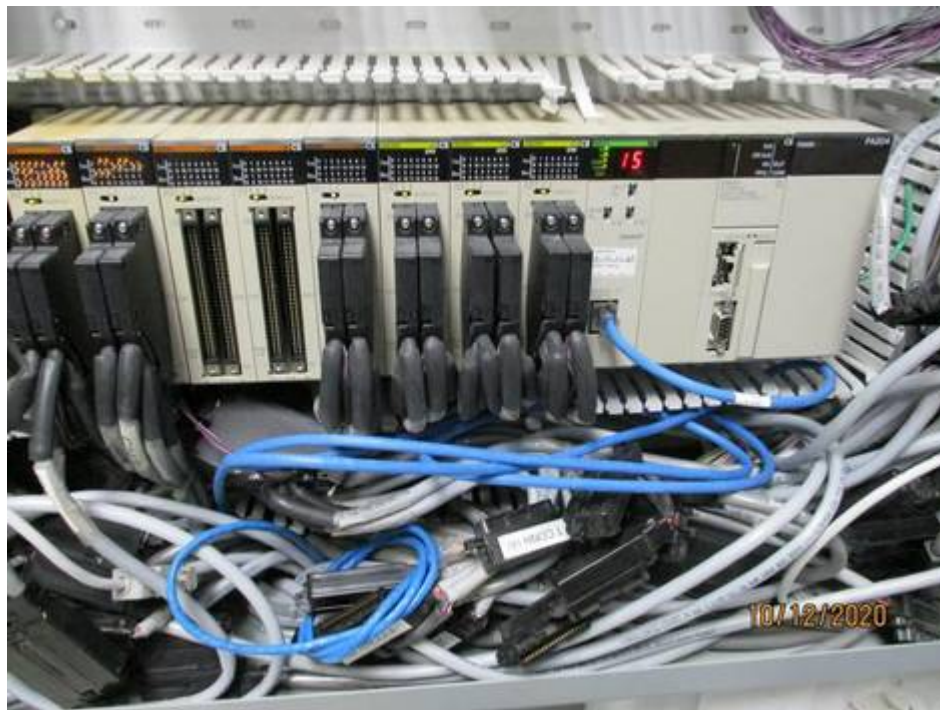
Figure 11 — PLC Locking Control System in Security Electronics Equipment room

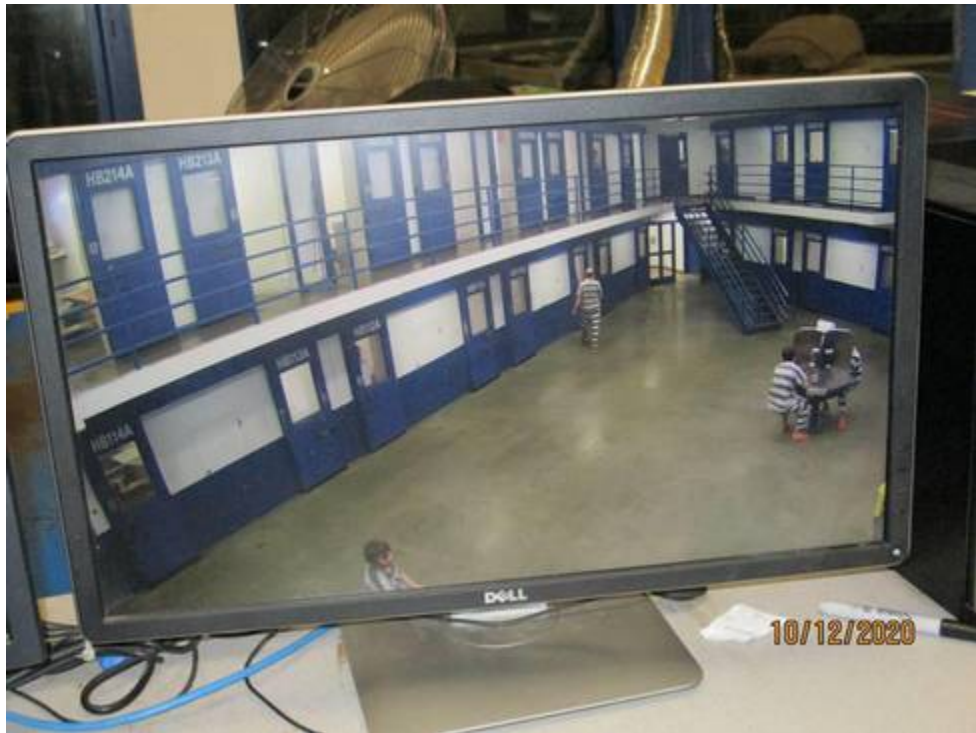
Figure 23— IP-CCTV Spot Monitor at control stations (typical)
