SUBJECT: Presentation of HSMM Building Assessment for the Tuxedo Elementary School

Building Assessment Tuxedo Elementary School

for
Henderson County

January 2006

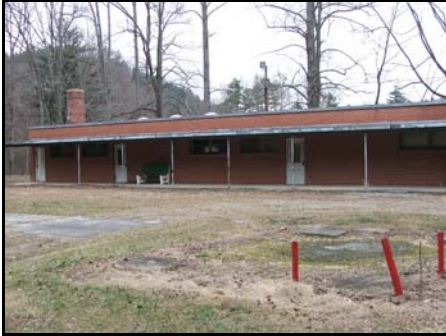
General Building Condition: Kindergarten Building

The 2600 SF Kindergarten Building was constructed in 1956 and consists of two classrooms and a boiler room. Its design is typical of school buildings designed in the 50's, with windows extending the width of the exterior wall and stretching from cabinet height to the underside of the roof structure. Skylights

Exterior walls are 12-inch cavity brick walls. Partition walls are brick walls. There was some cracking in the interior masonry wall where it intersects with the exterior wall. It is assumed that most of this cracking is caused by either thermal movement of the building or soil settlement under the wall. Additional detailed investigation is required to find the definite cause of the cracking in the wall. All the remaining walls appear to be in good condition.

The roof consists of a concrete slab supported by steel members. The slab and the interior steel members appear to be in good condition. Most of the exterior exposed steel members have visible rust and require immediate attention to provide rust inhibitive treatment. The canopy connecting the Kindergarten Building to the Main Building is in poor condition and would be unlikely to remain as part of a future use for the buildings.

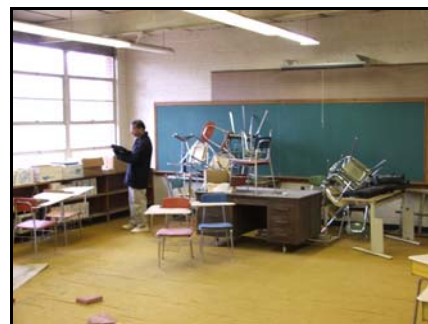
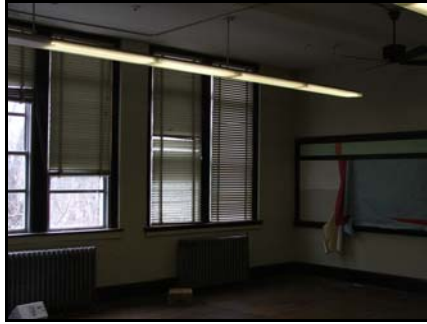
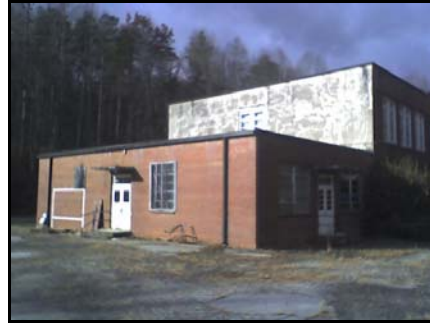
General Building Condition: Main School Building

The Main Building is a classic two-story school structure constructed as a grade school in 1924. A kitchen and dining room addition was added in 1952. The building has spaces designed as class rooms, administrative offices, and a multi-purpose auditorium / activity room with a small stage. Currently, this space serves as a precinct voting place. The original building is approximately 15,650 SF (not including a basement boiler room) and the 1952 addition is just over 2000 SF.

Reflecting the challenges of lighting these buildings at the time, the windows are very large and the ceilings are high, typically exceeding 12 feet.

Exterior walls are 12-inch cavity brick walls. Portions of the rear walls are plastered masonry. Partition walls are either brick or wood. All the walls appear to be in good condition.

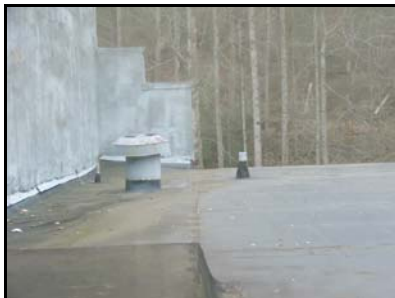
The overall building structure was found to be in good condition, with no visual evidence of any significant structural problems. Some cracks and staining on the ceiling caused by roof leaks were observed in some areas of the building. Additional detailed investigation is required to find the cause of the cracks and water leakage.
